## 2006 Floods in the Danube River Basin

**Flood risk mitigation for people living along the Danube:  
The potential for floodplain protection and restoration**

**Working paper**

Vienna, July 2006

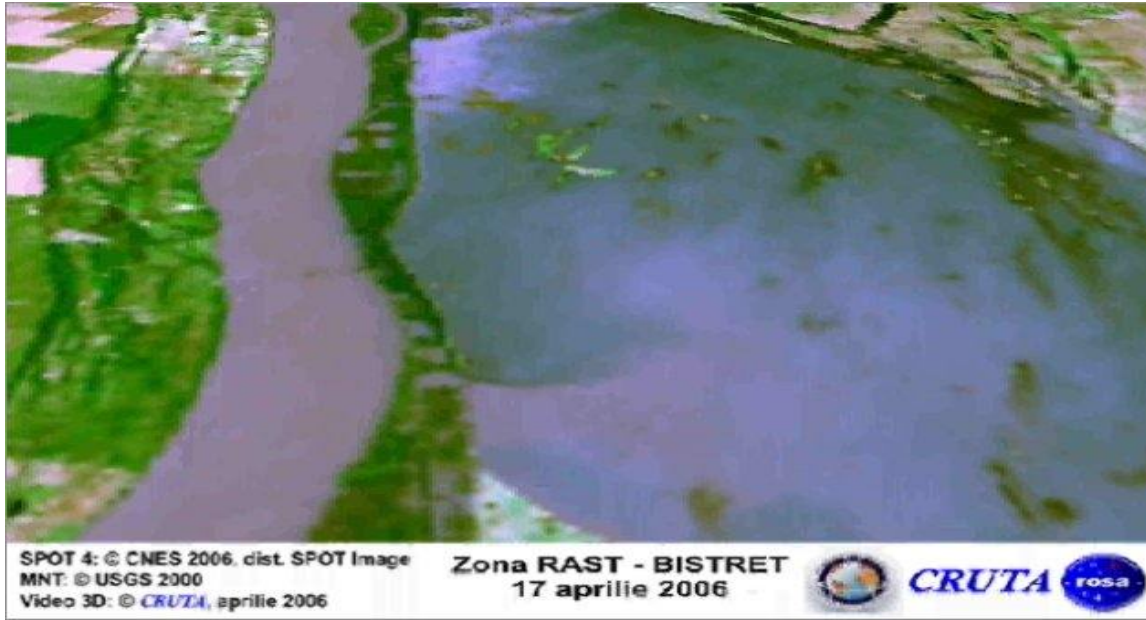
Figure 5: Danube near Bistret (on the right side) showing the very narrow river corridor between the Bulgarian bank (on the left side, mostly limited by natural terraces) and the flooded polder area with dike breaks and overtopping turbid Danube water in the fore- and background (for reference see the bottom of the picture)

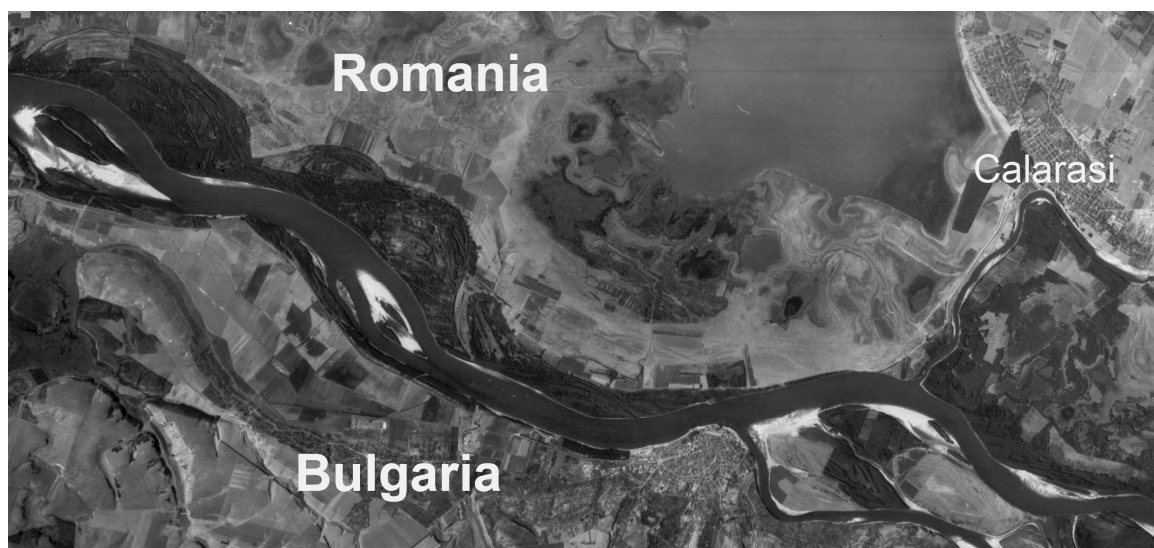
**Figure 7: Former floodplain of the Balta Calarasi in 1962 before the establishment of the agricultural polders and melioration (compare Map 3).**

The current uses of the former floodplain, mostly characterized by agriculture and forestry, can be taken from the European CORINE land use classification and compared to the historical situation taken from historical maps and aerial images (compare Fig. 7 and Tab. 9). Further assumptions about the land uses and main habitat types should be made from more detailed studies of the surrounding areas, where available. Analysis of the satellite images from the 1960s - before the polders were built - allows one to quantify the most important aquatic and semi-aquatic structures of the riverine landscape, as well as the forests.

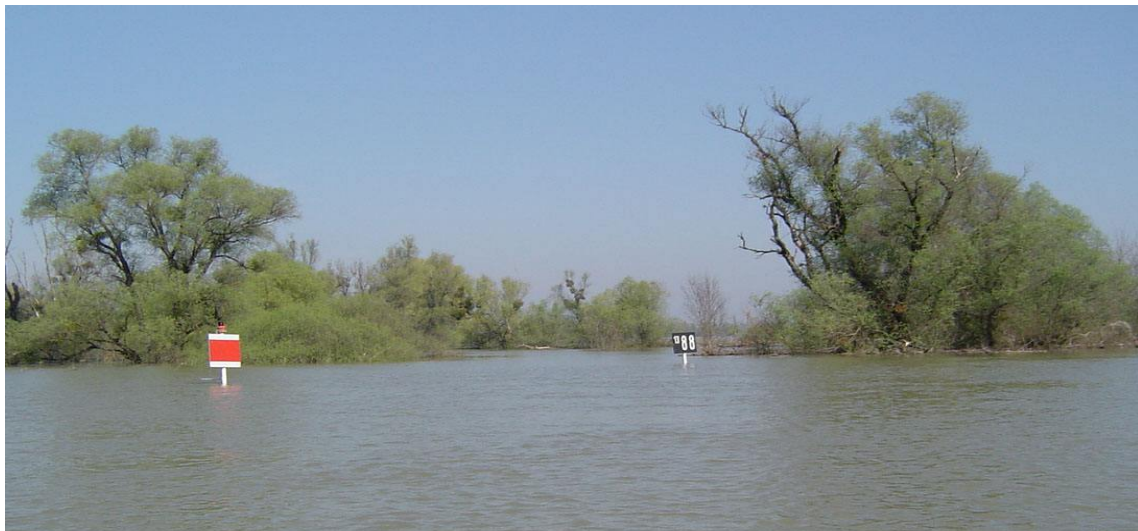
**Figure 8: View of the flooded Kopački Rit during the 2006 flood at river kilometre 1,388 from the main river with navigation signs (photo by Boris Bolsec, Nature Park Kopački Rit)**

Remaining large floodplains, such as the Kopački Rit (Fig. 8) illustrate the important role that floodplains play in regional flood risk mitigation. 2006 saw the flooding of the entire floodplain of the Kopački Rit, as well as the adjacent areas from the Danube river km 1367 to 1409 (42 km) with a size of 26,500 ha. The retention volume of this area is about 700 million m<sup>3</sup>. As the area is naturally flooded, the lowering of the flood peak is smaller than with a managed polder, but still exceeds at least 0,5 m in comparison with measurement stations upstream from the Kopački Rit (Mohacs in Hungary). The floodplain retains water and considerably slows the rise of water levels.
